Re: Notice of Violation  
Compliance Evaluation Inspection  
ILD 005 267 810

COMPLIANCE EVALUATION INSPECTION REPORT

INSTALLATION NAME: Dixline Corporation

DATE OF INSPECTION: August 7, 2015

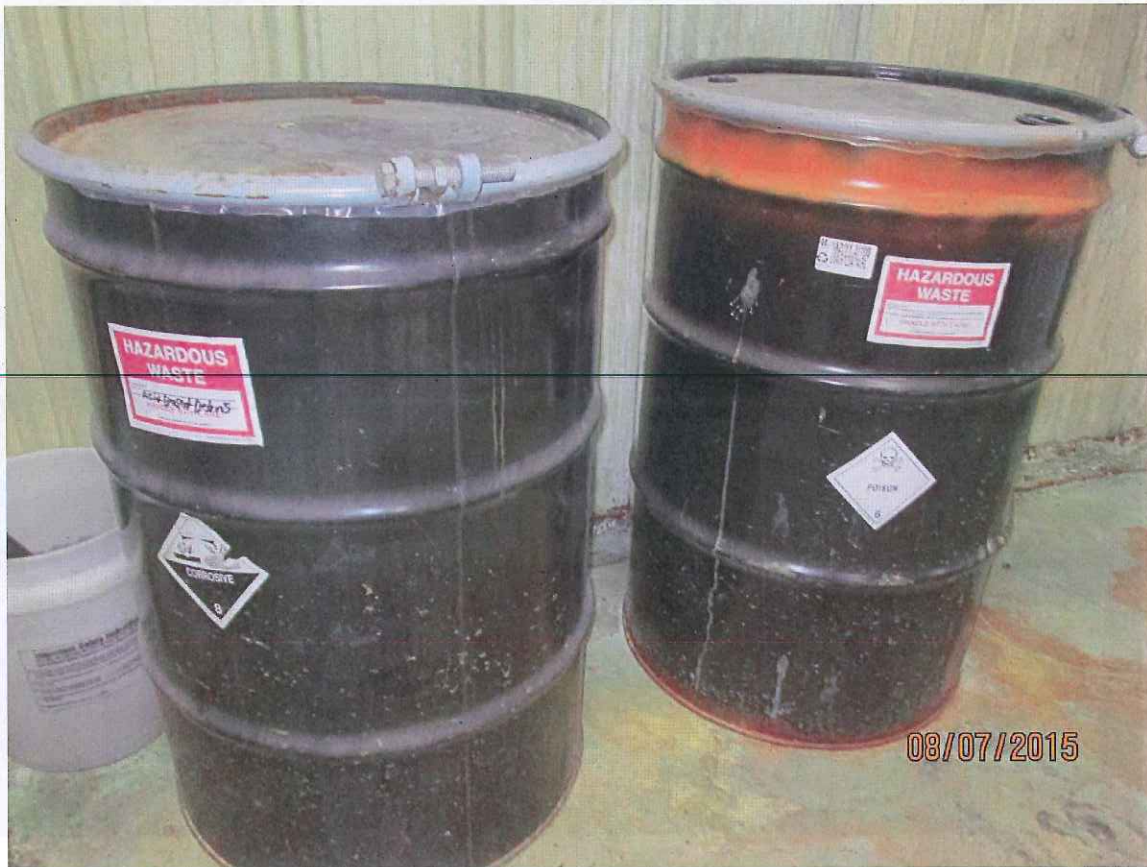
The Dixline site inspection began at approximately 10:25 a.m. in the Plating Line. The plating line consisted of several processing baths, including: nickel, trivalent chrome, cyanide, copper, acid copper, zinc sulfate, sulfuric acid, hydrochloric acid, and several rinse water baths. Two hazardous waste satellite containers of acid-based debris and cyanide-based debris were being accumulated here (*see photo 1*).

Photo 1. Photographer: G. Scambiatterra. Time: 10:39 a.m.  
Description: Plating line satellite containers. Left container has acid-based debris. Right container has Cyanide-based debris.

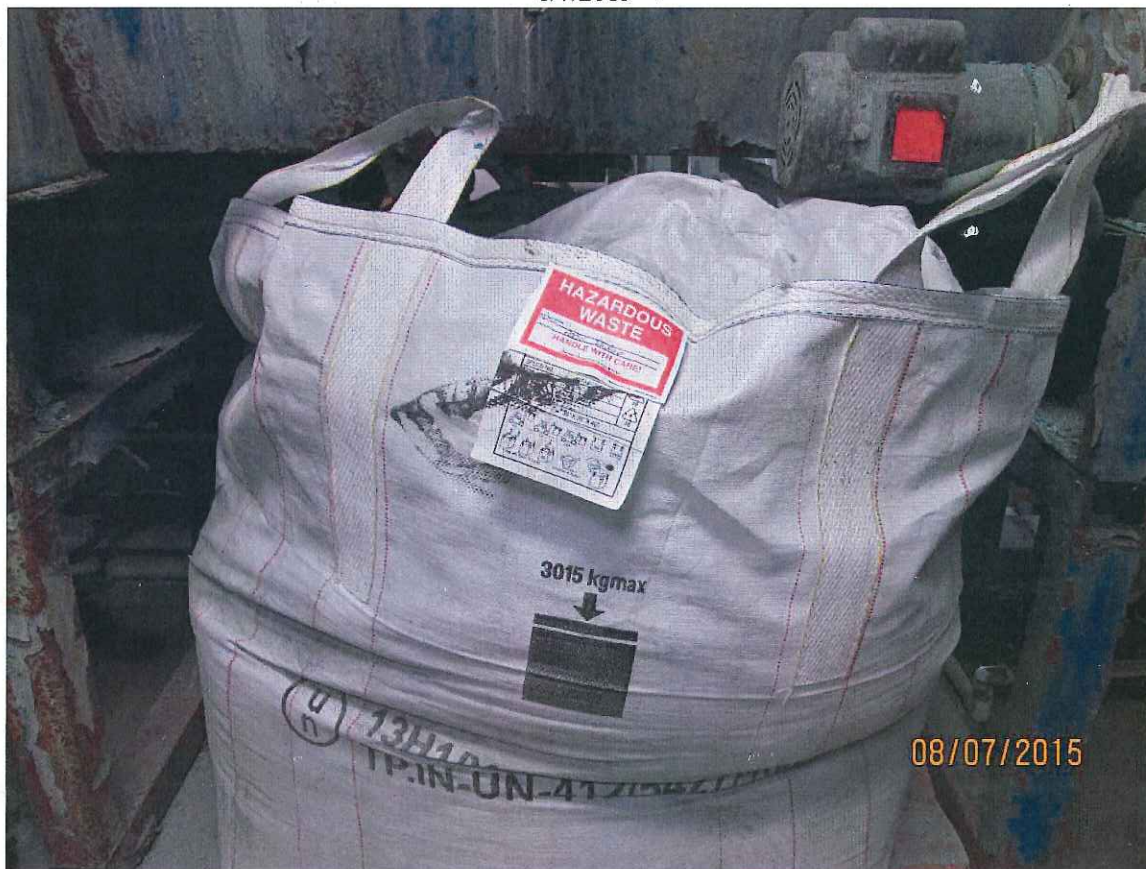
At the time of the inspection, the Dixline was accumulating two containers of hazardous waste without the accumulation start date.

The next area we inspected was the onsite Wastewater Treatment System (WWTS) Area. Hazardous waste sludge (F006) is generated and stored here. I observed two F006 yard bags in this area (*see photos 2-3*). Neither of the F006 yard bags contained an accumulation start date, nor was the yard bag in photo 3 labeled with the words "Hazardous Waste." Nearby were additional containers of hazardous waste, including four debris containers (*see photo 4*) and one cyanide carbonate container (*see photo 5*). All these containers had the accumulation start dates and were labeled with the words "Hazardous Waste." In the area there was also a container of non-hazardous UV Clear Coat waste (*see photo 6*).

Photo 2. Photographer: G. Scambiatterra. Time: 10:48 a.m.  
Description: F006 yard bag. No accumulation start date.

During the inspection, as observed by EPA, and after the inspection, as documented in your August 7, 2015 emails to EPA, you took certain actions to establish compliance with the permit exemption conditions in paragraphs 1-2, above. Based on the information received from Dixline on August 7, 2015, EPA is not planning additional enforcement actions based on this inspection at this time. This letter does not limit the applicability of the requirements evaluated, or of other federal or state statutes or regulations. EPA appreciates Dixline's cooperation.

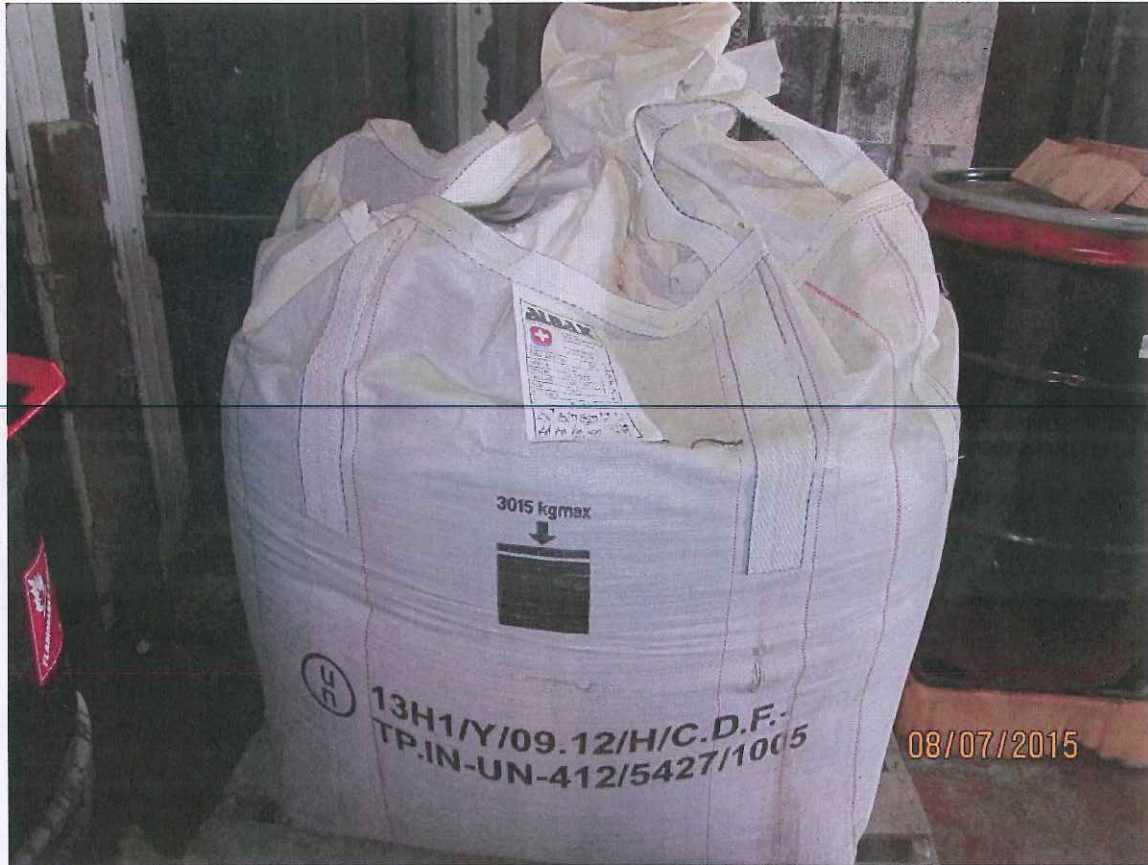
At the time of the inspection, Dixline was accumulating one container of hazardous waste without the words "Hazardous Waste."

Description: F006 yard bag. No accumulation start date. No "Hazardous Waste" label or markings.

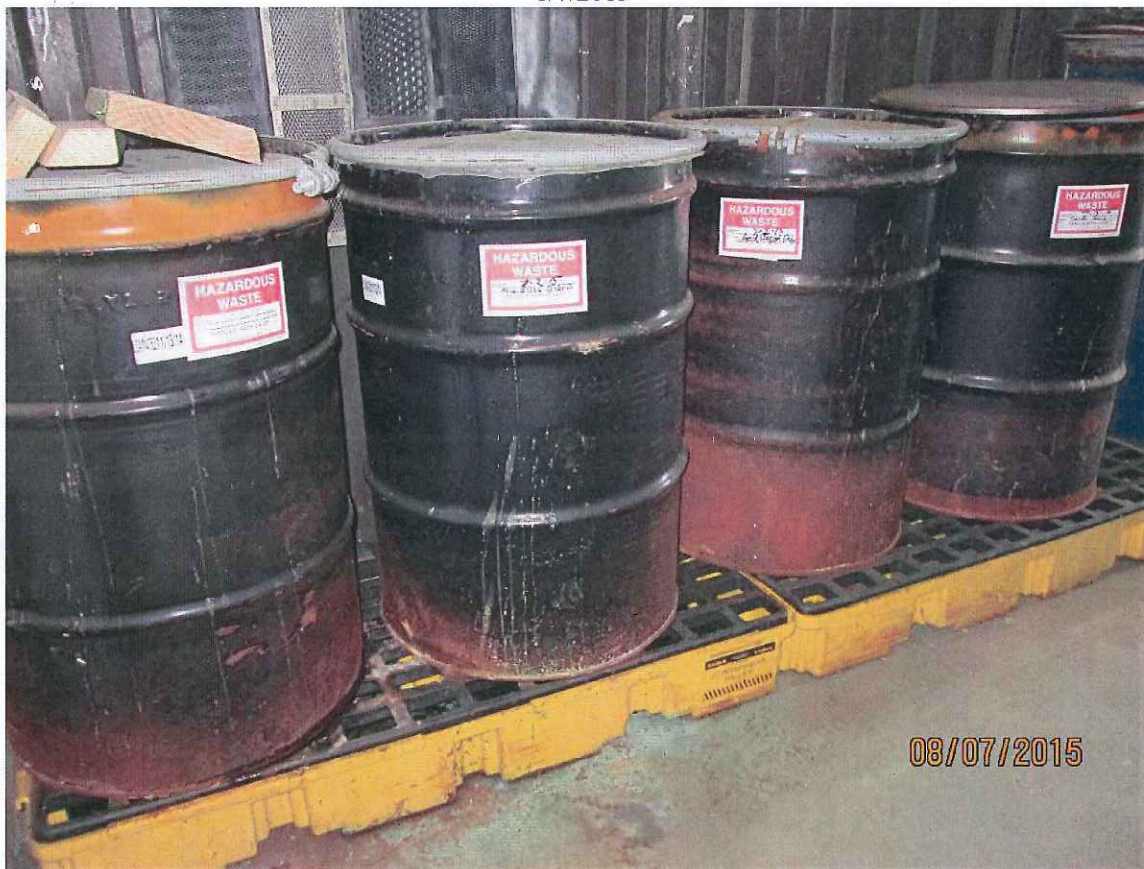
Photo 4. Photographer: G. Scambiaterra. Time: 10:55 a.m.  
Description: Acid and cyanide debris containers in storage.

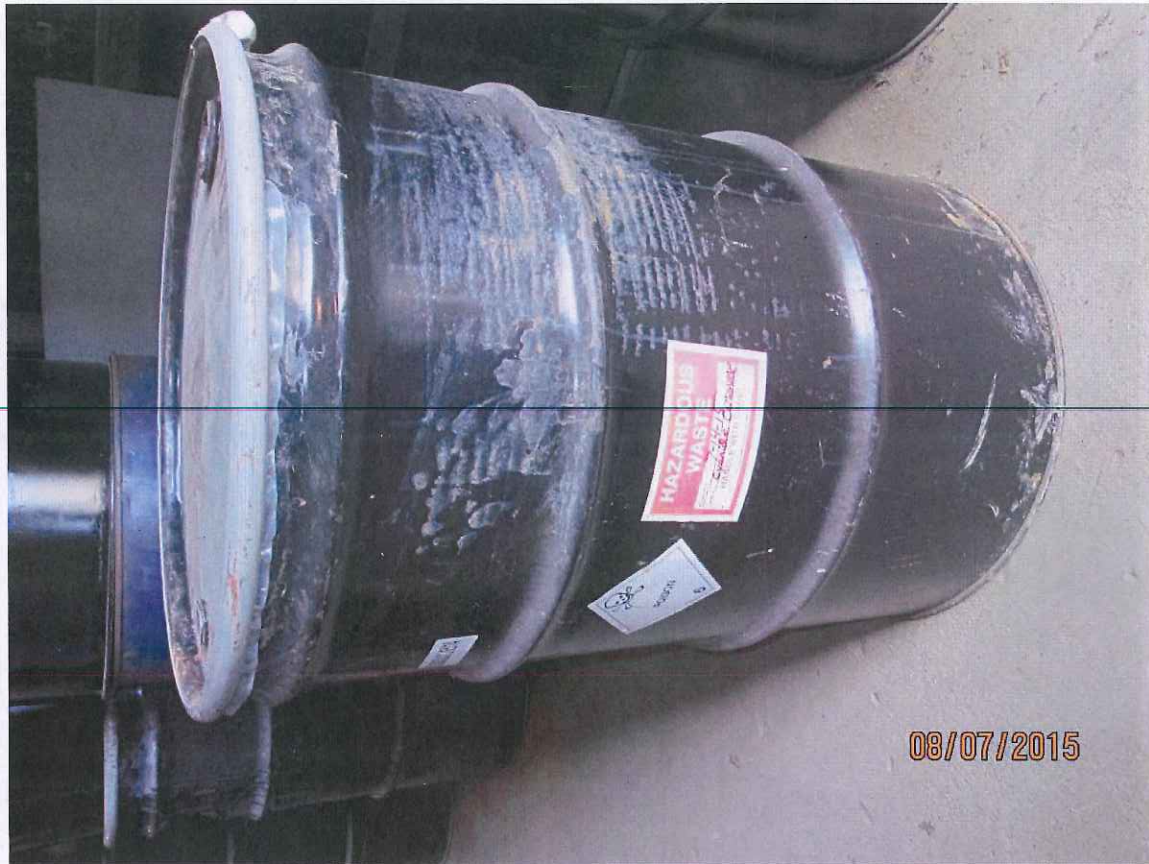
Photo 5. Photographer: G. Scambiaterra. Time: 10:55 a.m.  
Description: Cyanide carbonate waste in storage.

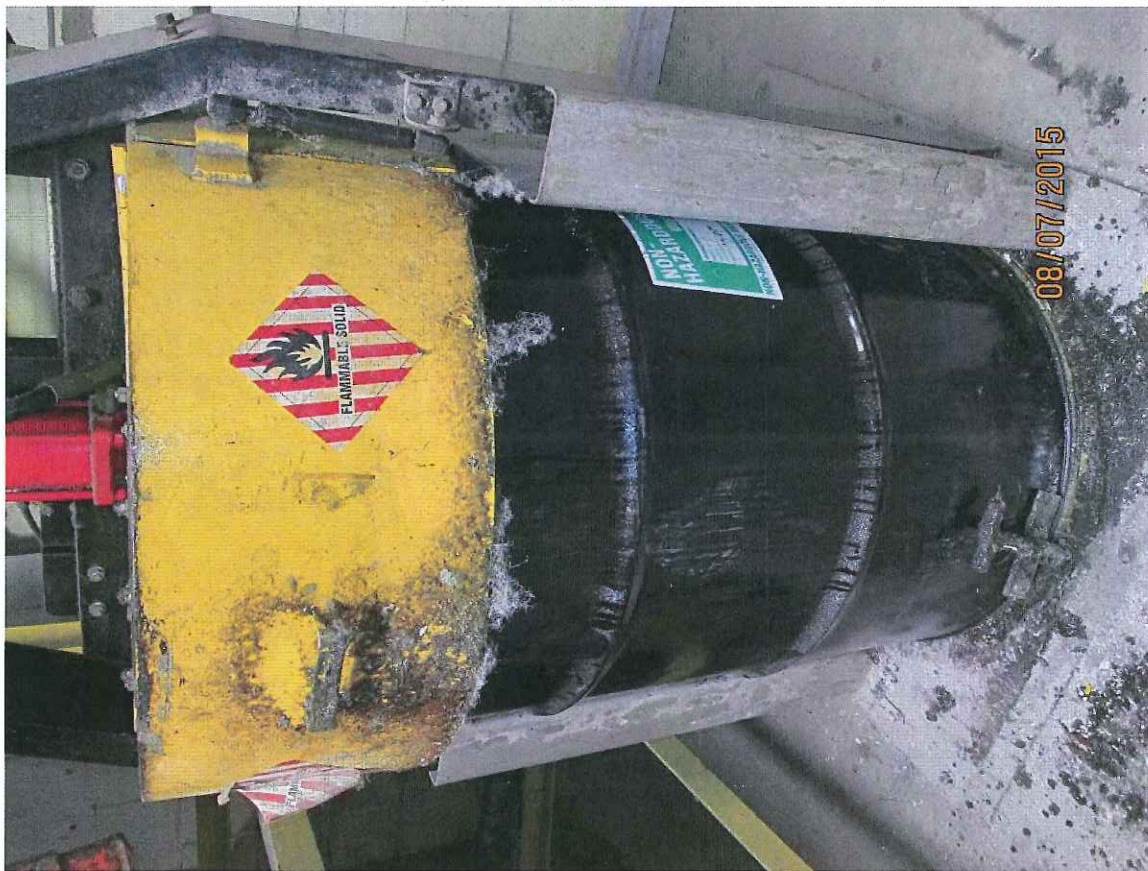
Photo 6. Photographer: G. Scambiatterra. Time: 11:04 a.m.  
Description: UV Clear Coat waste, non-hazardous.

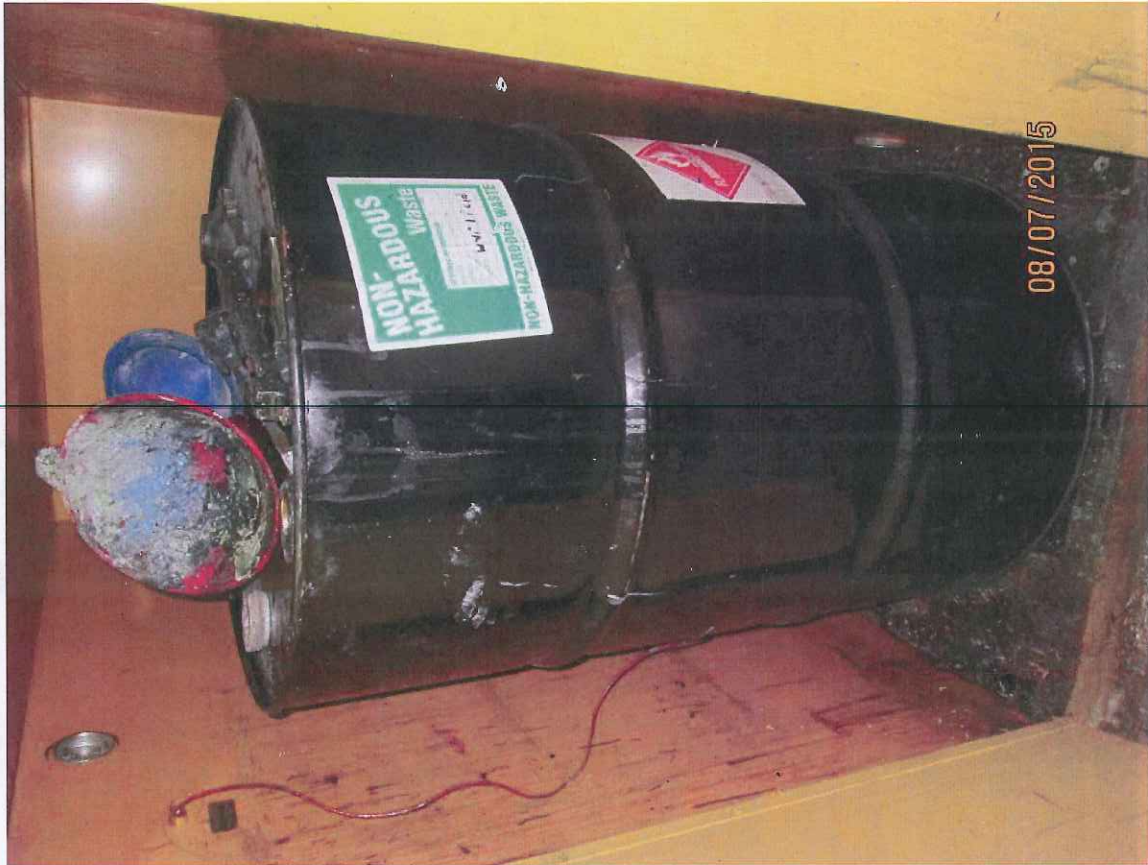
At the time of the inspection, Dixline was accumulating one satellite container of hazardous waste in the Buffing Department with the words "Non-Hazardous Waste" instead of "Hazardous Waste."

We then walked to the Buffing Department. Casts, formed in the Die Cast Building, are brought here and buffed for prepping before being plated. There was a satellite container of hazardous UV liquid in this area (*see photo 7*). The container was labeled with a non-hazardous waste label and I pointed this out to Mr. Hillan. The buffing department is also where parts are coated with paint and thinner is used to clean the painting equipment.

Photo 7. Photographer: G. Scambiaterra. Time: 11:08 a.m.

Description: UV liquid waste, hazardous waste. Buffing Department. Labeled with a non-hazardous label.

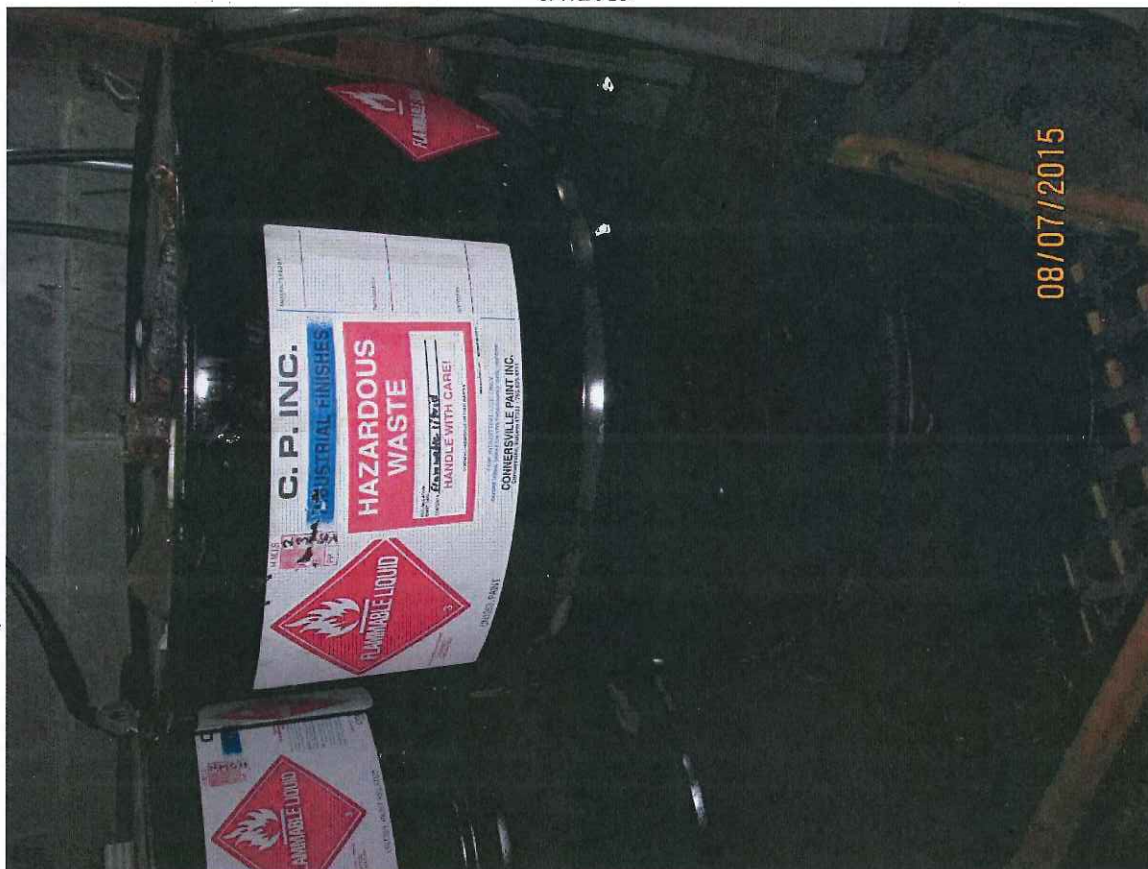
The final areas we inspected were the Vacuum Metal Area and the Die Casting Building. In the Vacuum Metal Area, base coating operations on metal and plastic occur. Top coating is accomplished with a solvent-based coating. There was a container of hazardous waste coatings in this area (*see* photo 8). The Die Cast Building is where zinc ingots are melted and then formed into casts. I did not observe any hazardous waste in the Die Casting Building.

Photo 8. Photographer: G. Scambiaterra. Time: 11:20 a.m.  
Description: Coating waste, hazardous waste. Vacuum Metal Area.
